FOIA request #EPA-R6-2014-002460

**SUBJECT:** Transmittal Memo – Compliance Monitoring Report

**FACILITY NAME:** Louisiana Land & Water Co Inc – Cooper Lake/Lakeview  
Subdivision STP

### **NPDES Inspection Report Information**

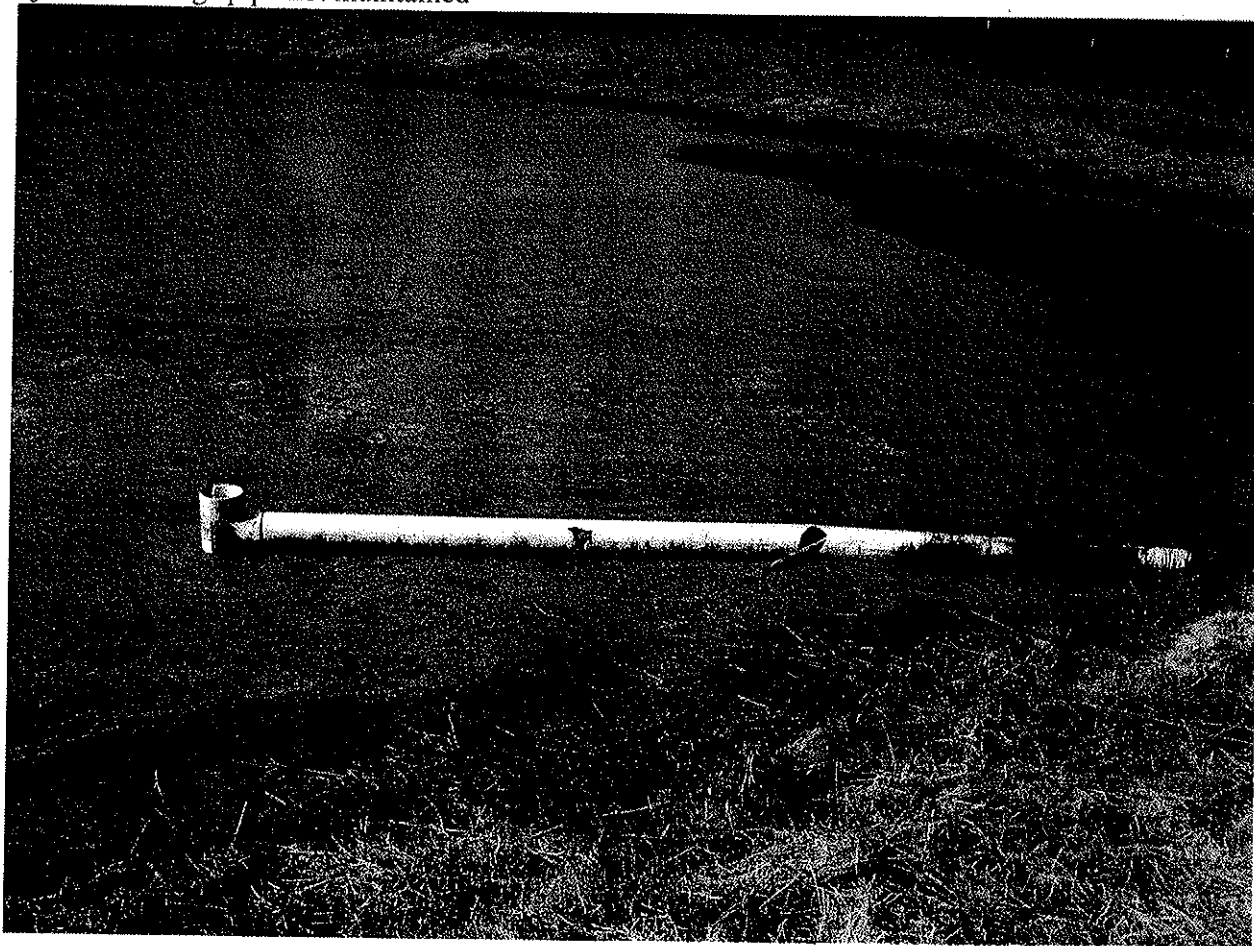
Photo: 1 of 11

**Subject:** Discharge pipe not maintained

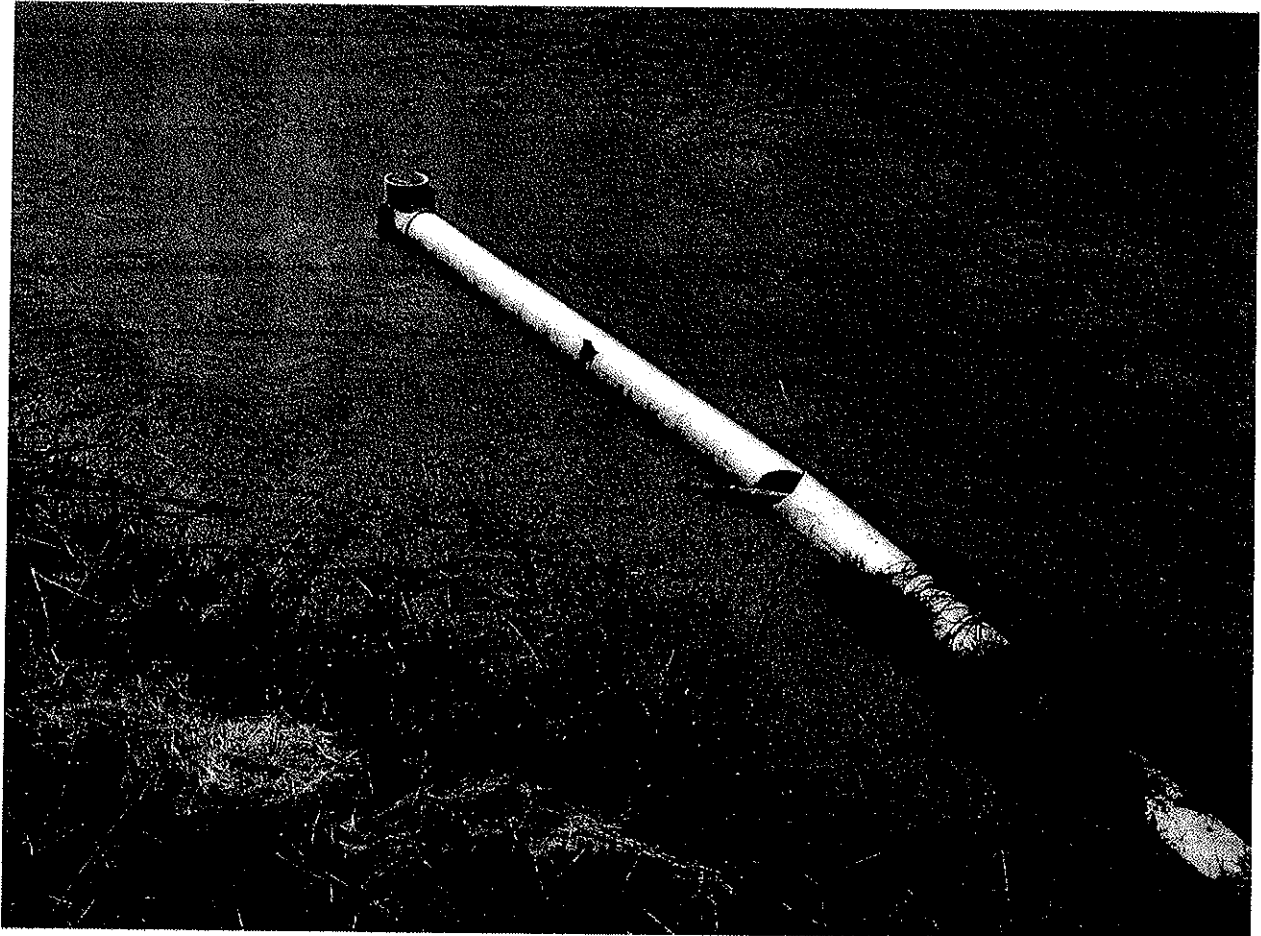
**Official Photograph Log**  
Photo: 2 of 11

**Subject:** Discharge pipe not maintained

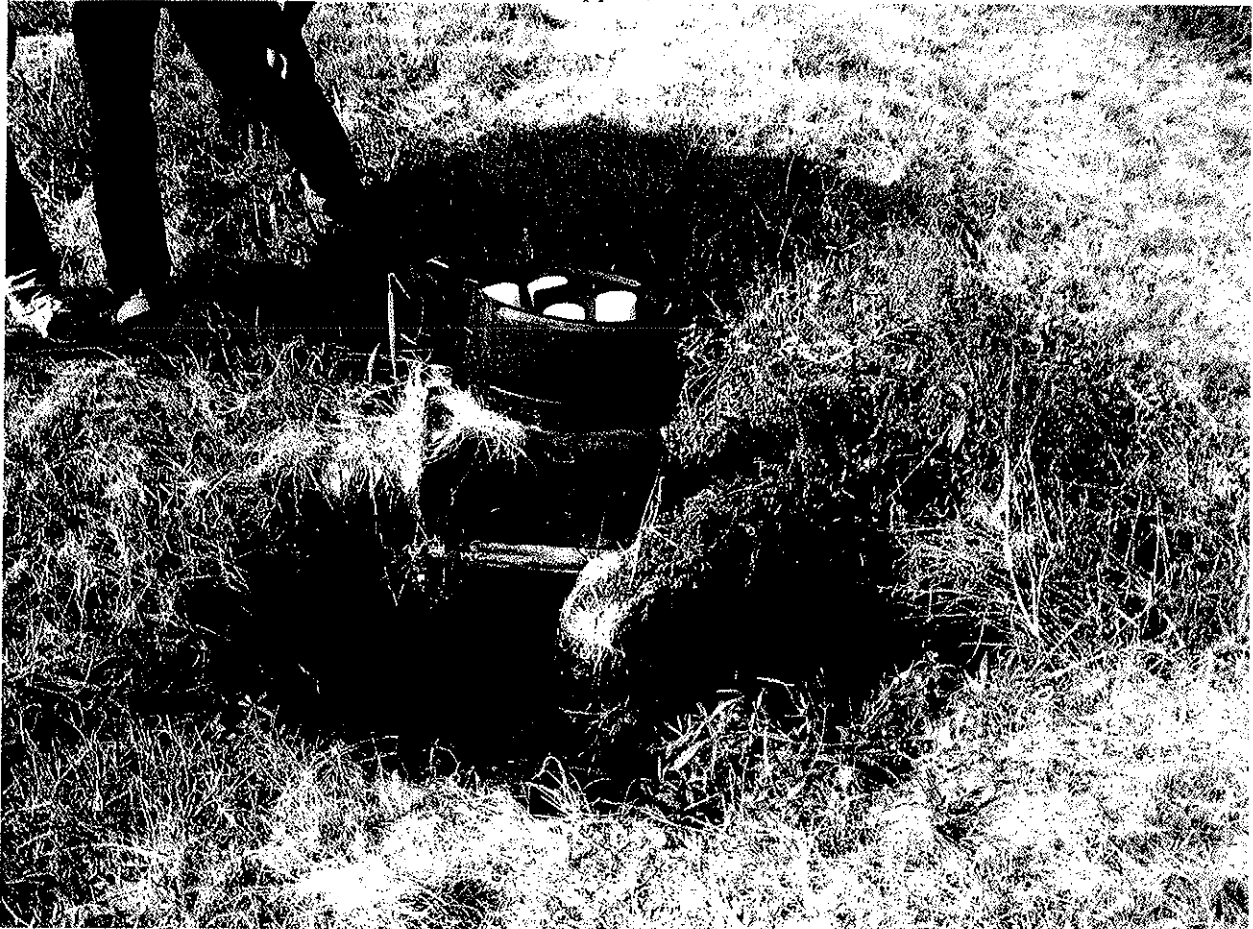
Photo: 3 of 11

**Subject:** Chlorine Contact Chamber; no lid, no support, no chlorine in tubes

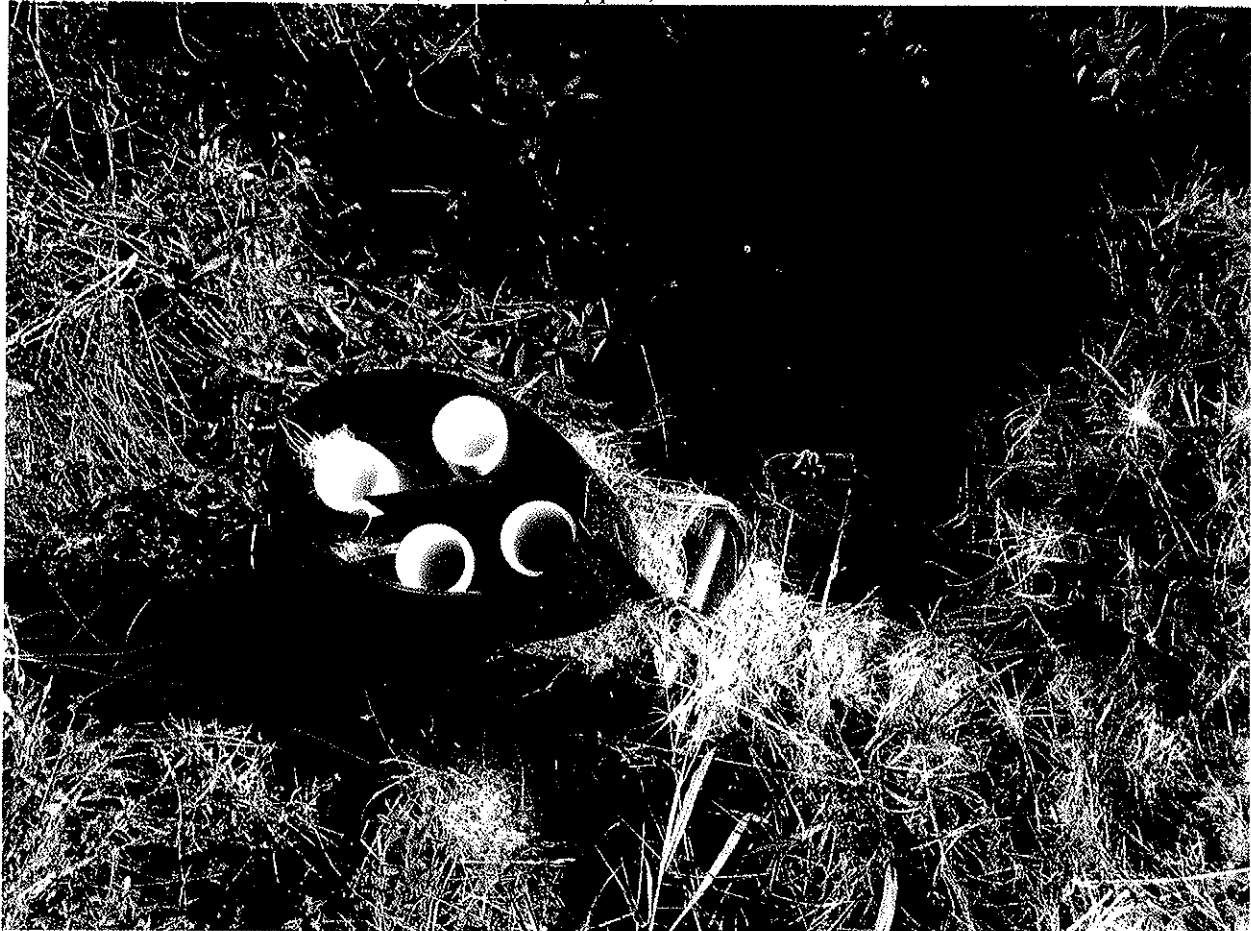
Photo: 4 of 11

**Subject:** Chlorine Contact Chamber; no lid, no support, no chlorine in tubes

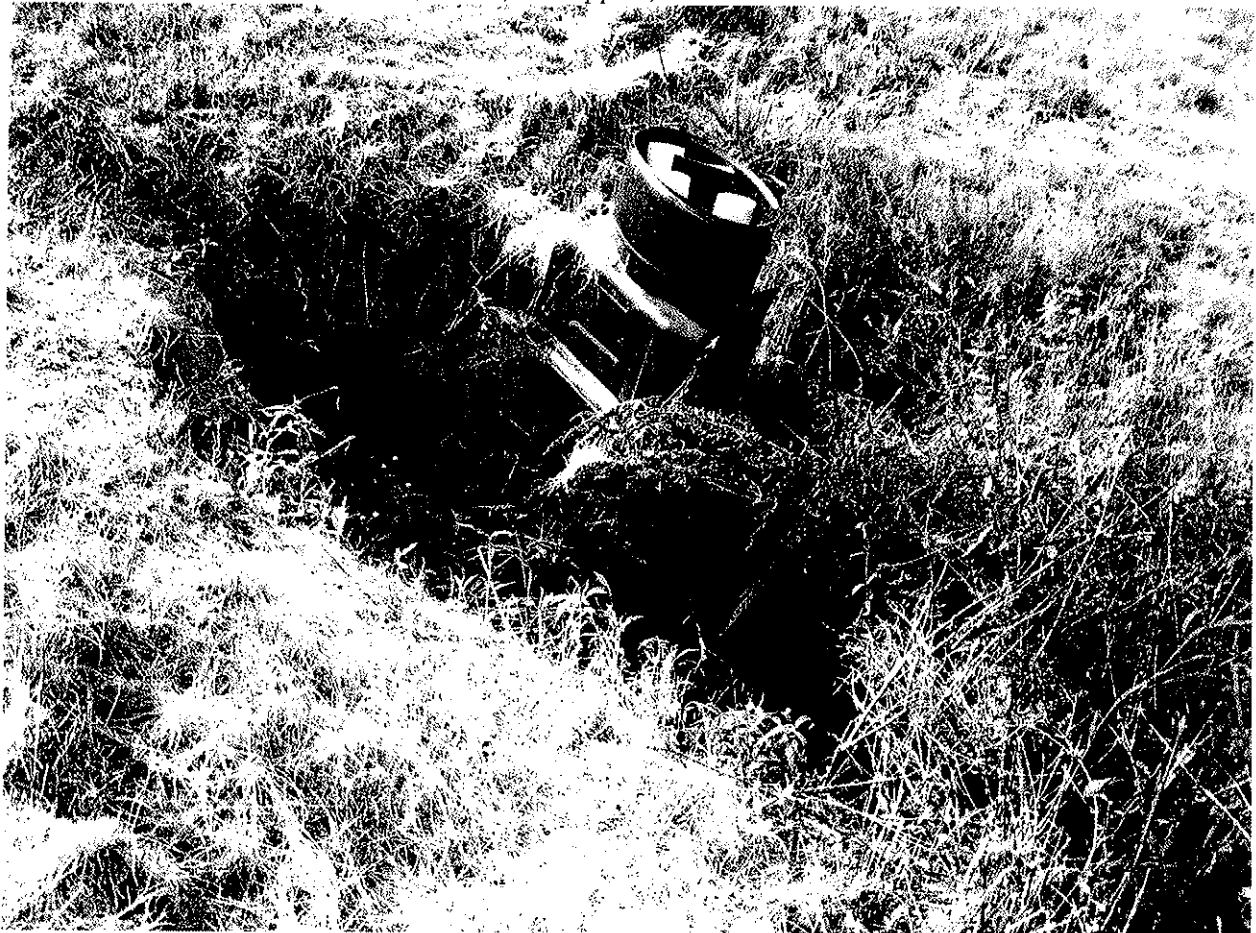
Photo: 5 of 11

**Subject:** Chlorine Contact Chamber; no lid, no support, no chlorine in tubes

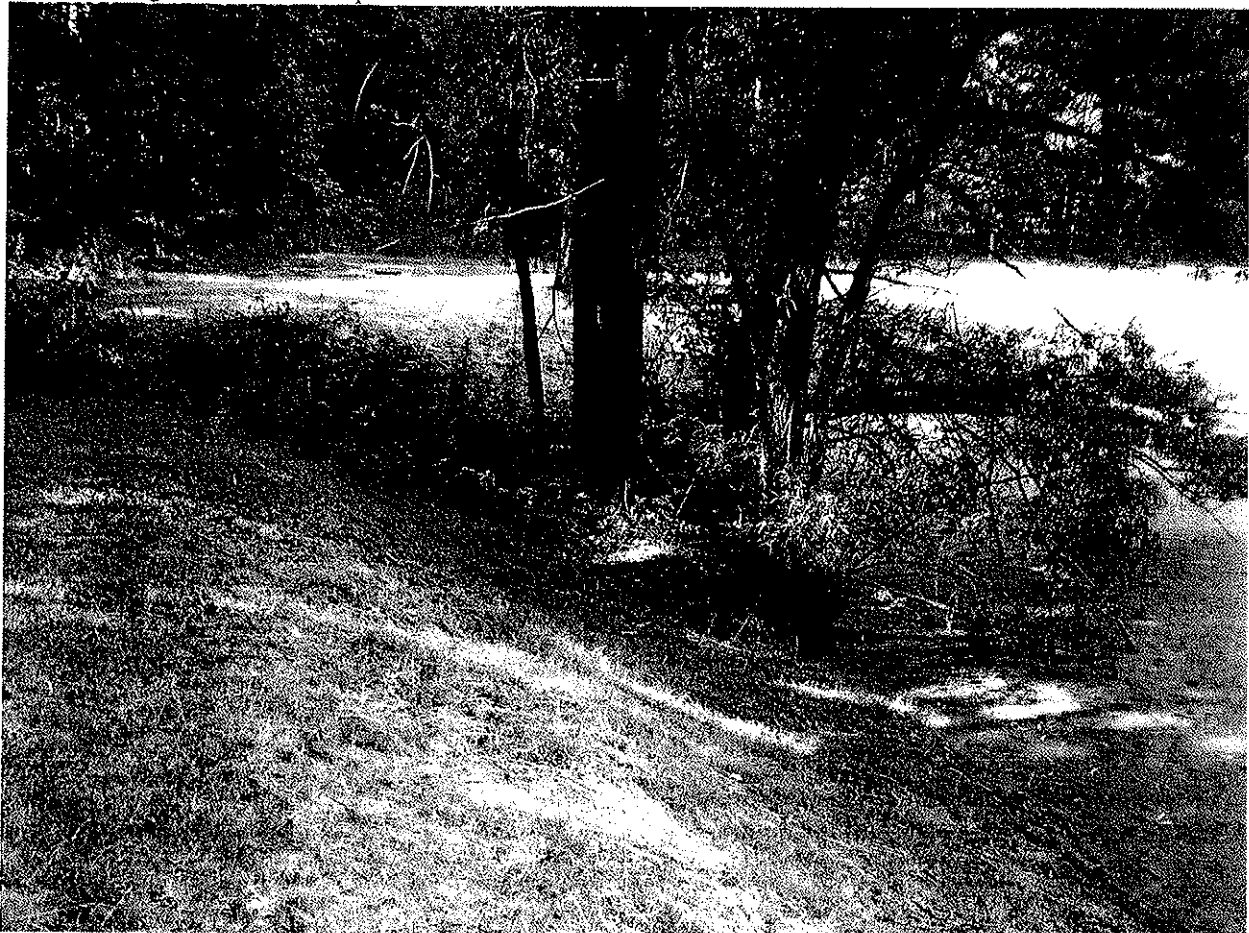
Photo: 8 of 11

**Subject:** Overgrown oxidation pond banks

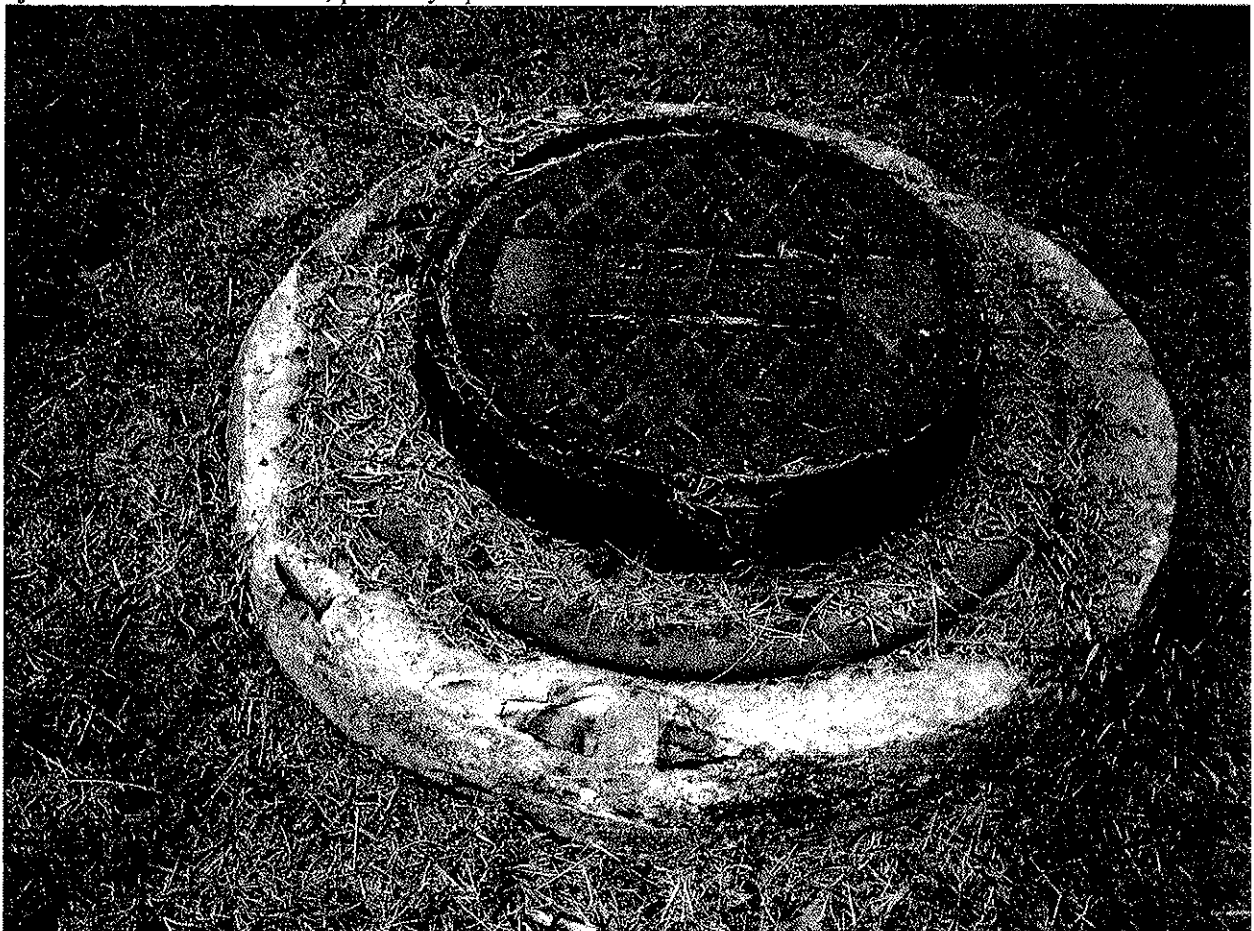
**Subject:** Manhole not secure, partially open

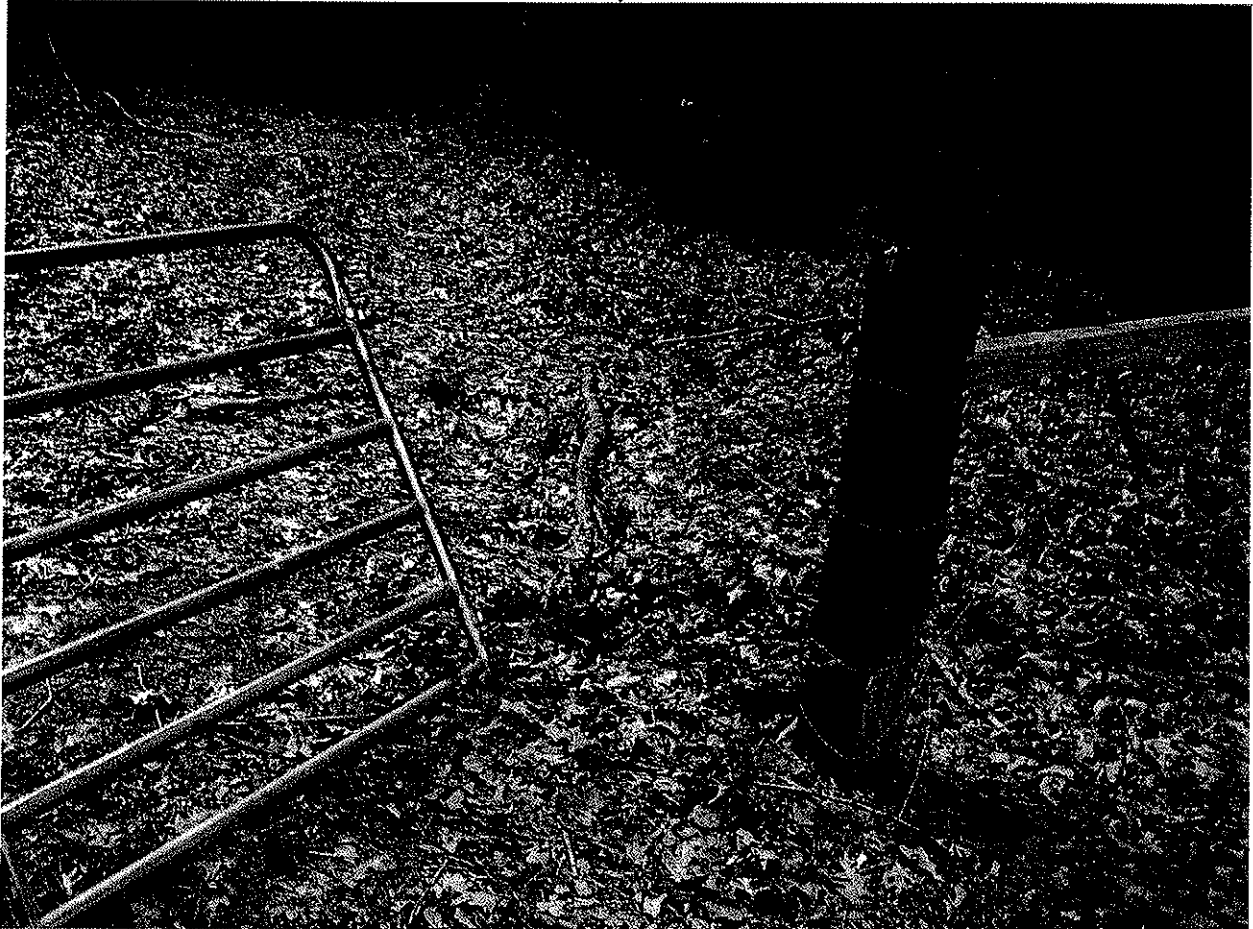
**Subject:** Entrance to the wastewater treatment facility not secure

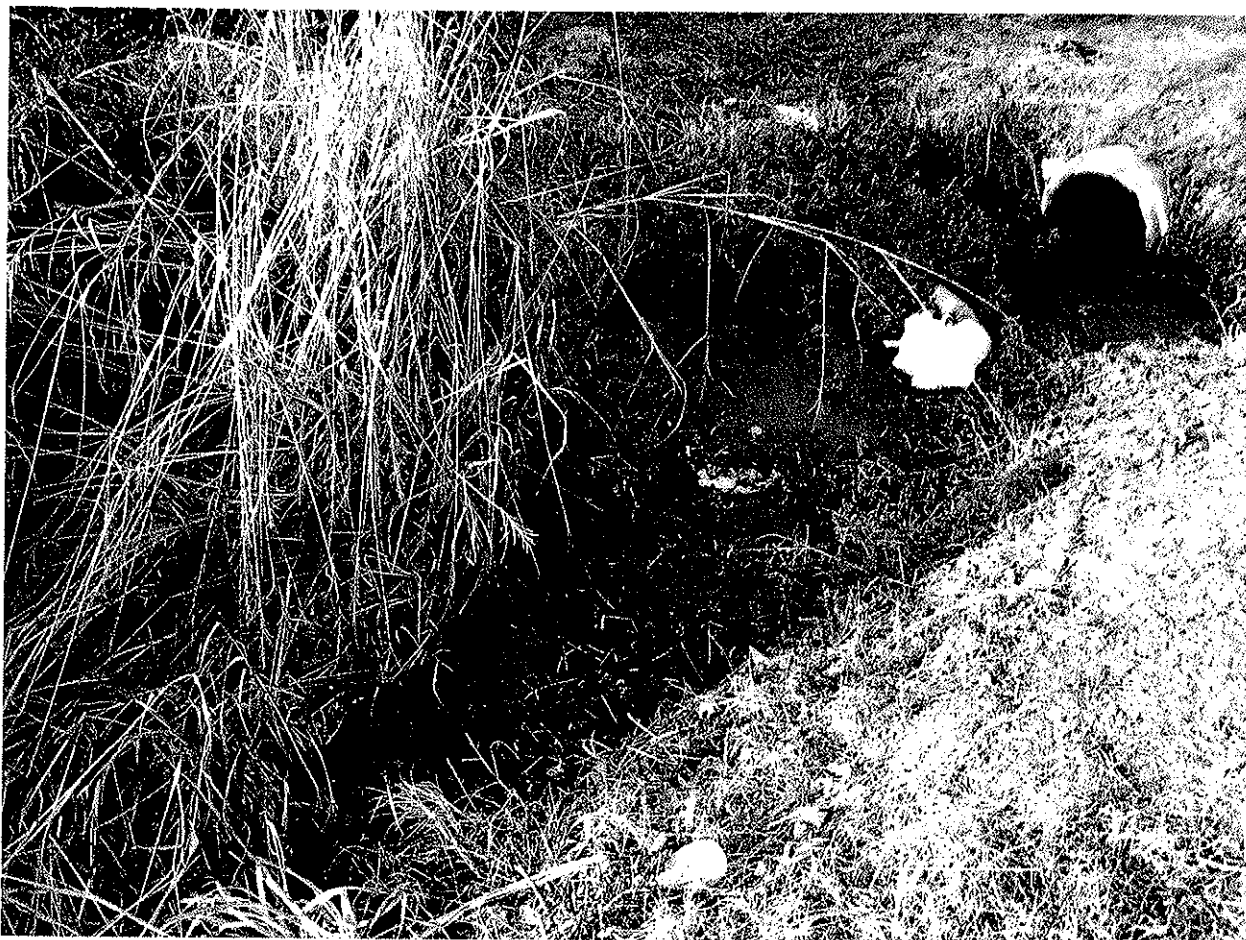
Subject: Discharge into ditch

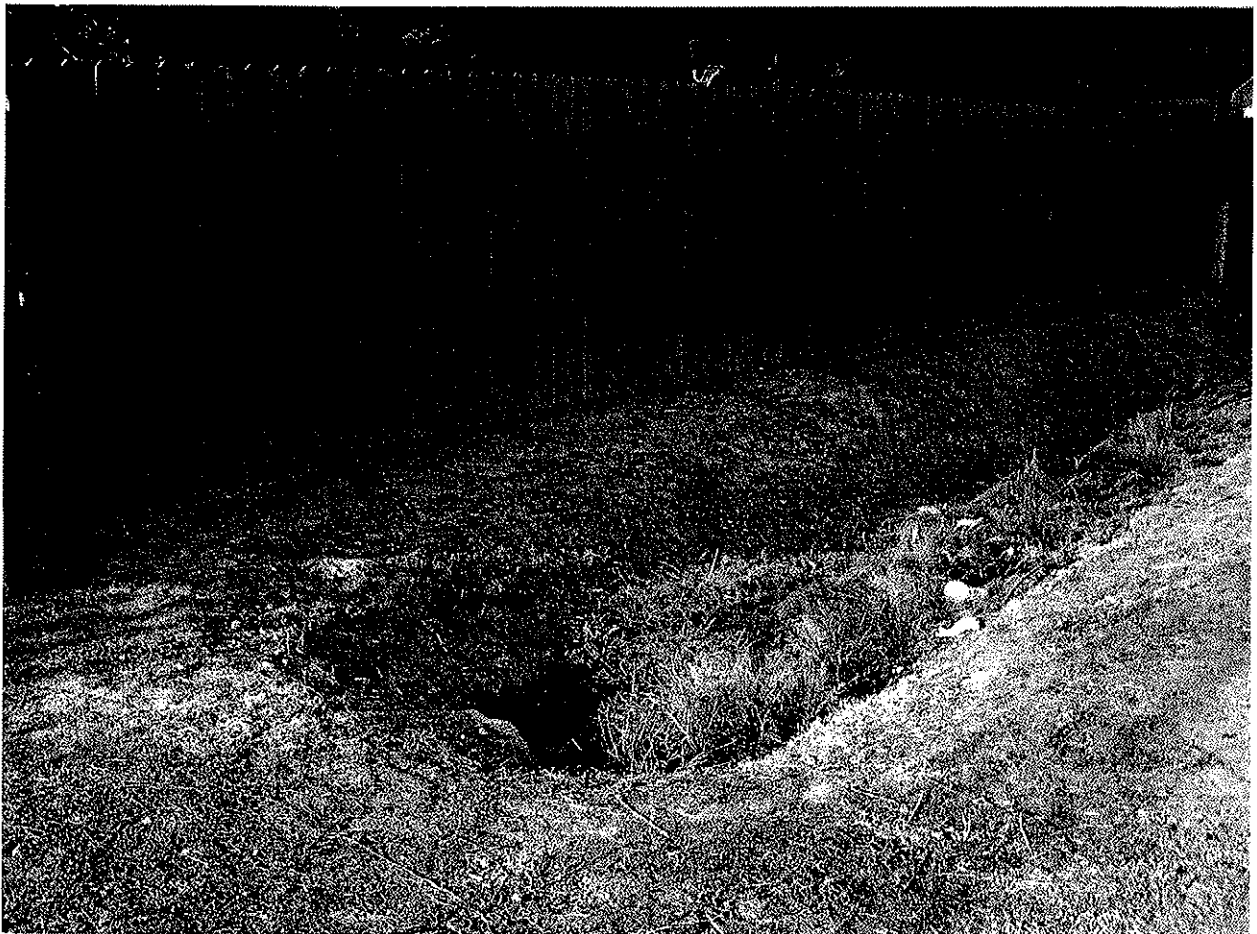
**Subject:** Discharge into ditch

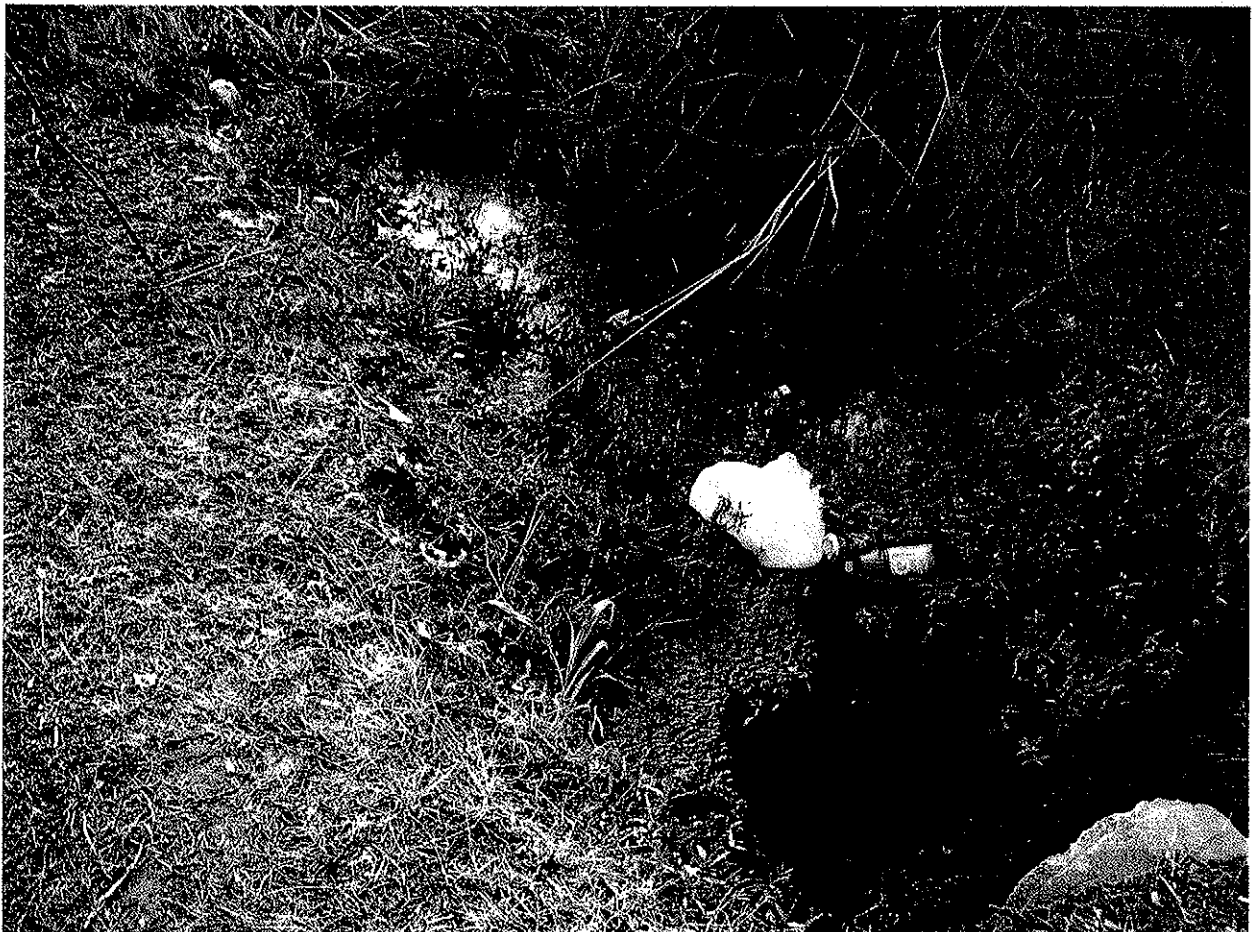
**Subject:** Discharge into ditch

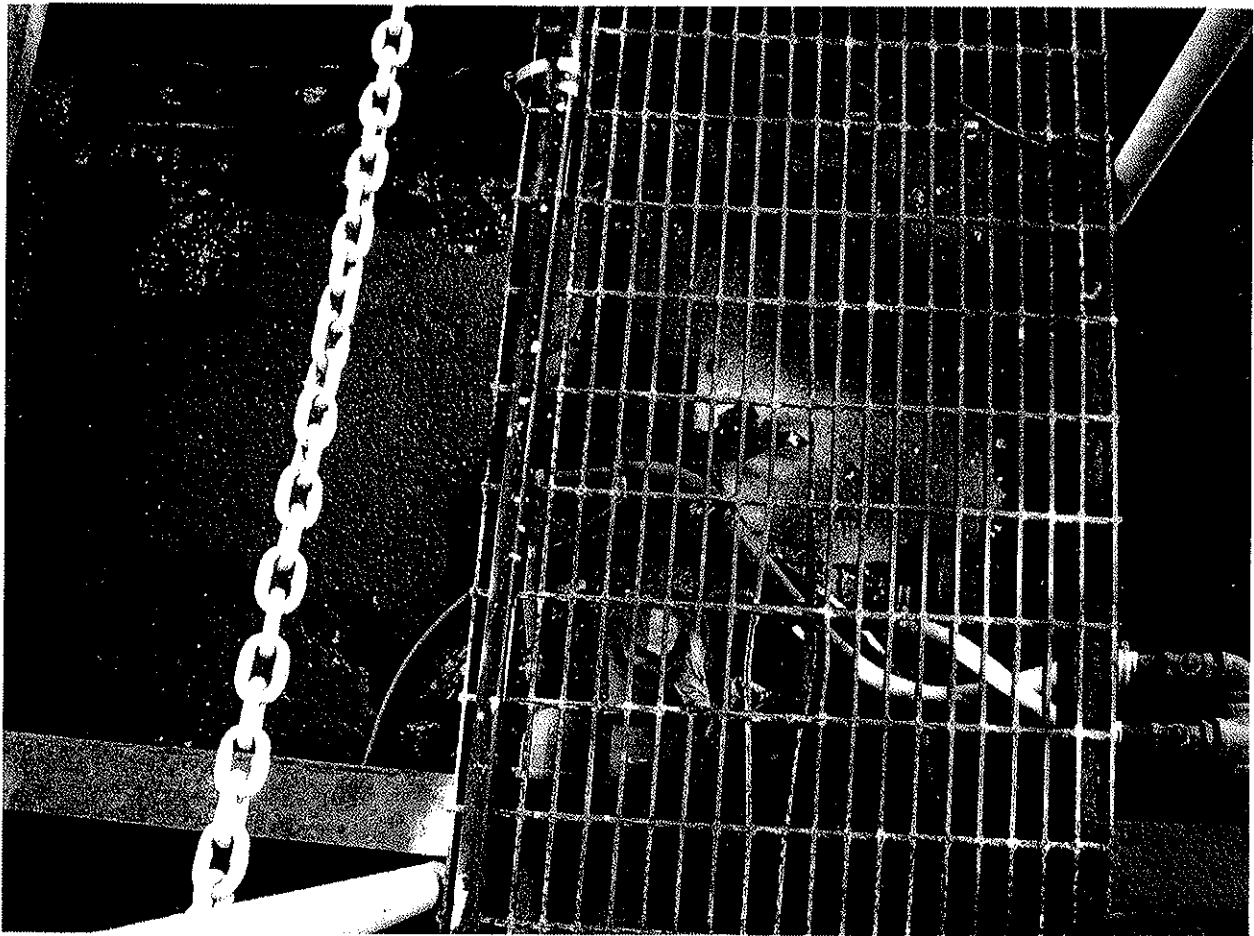
**Subject:** Solids and debris located in the sewage treatment plant

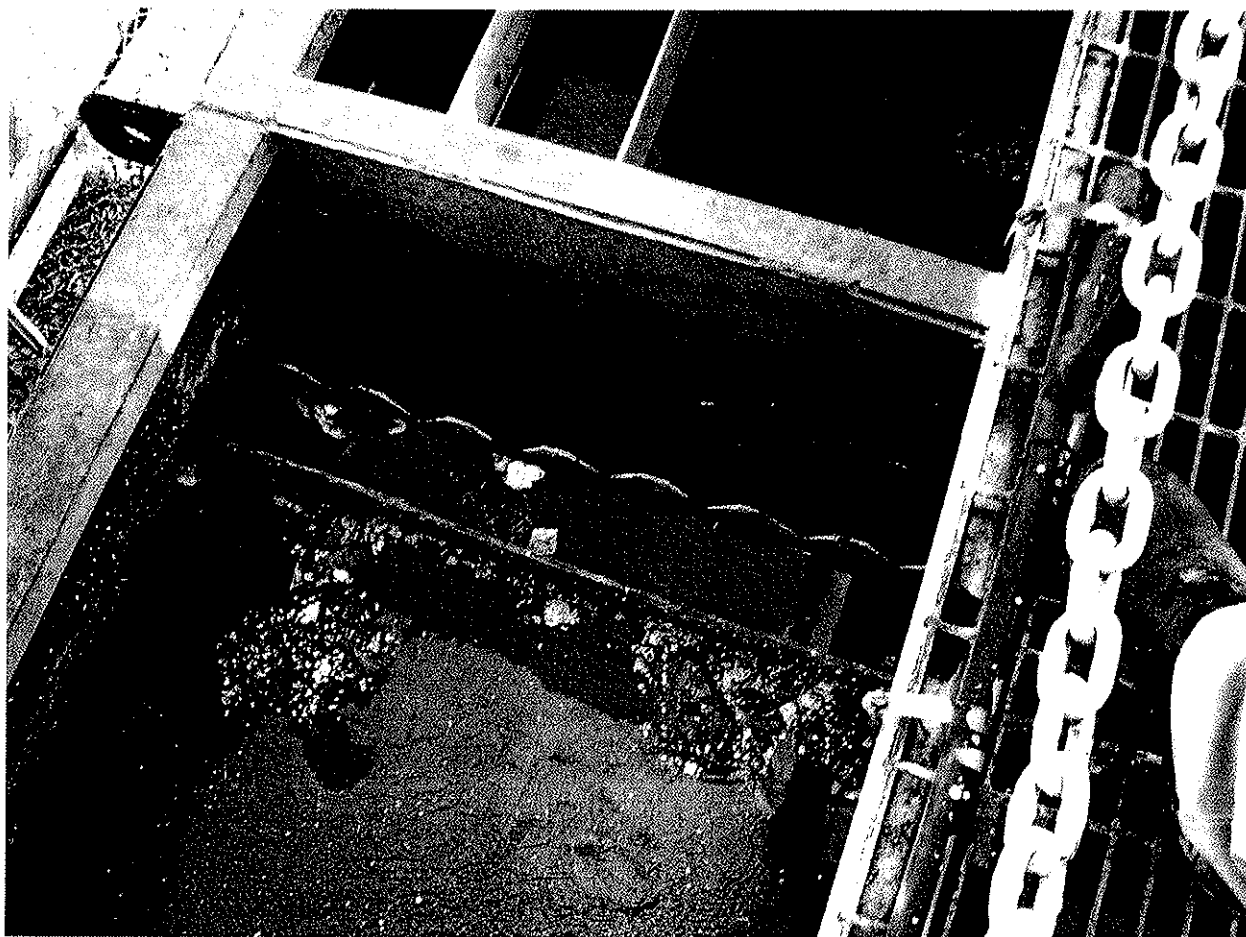
**Subject:** Solids and debris located in the sewage treatment plant

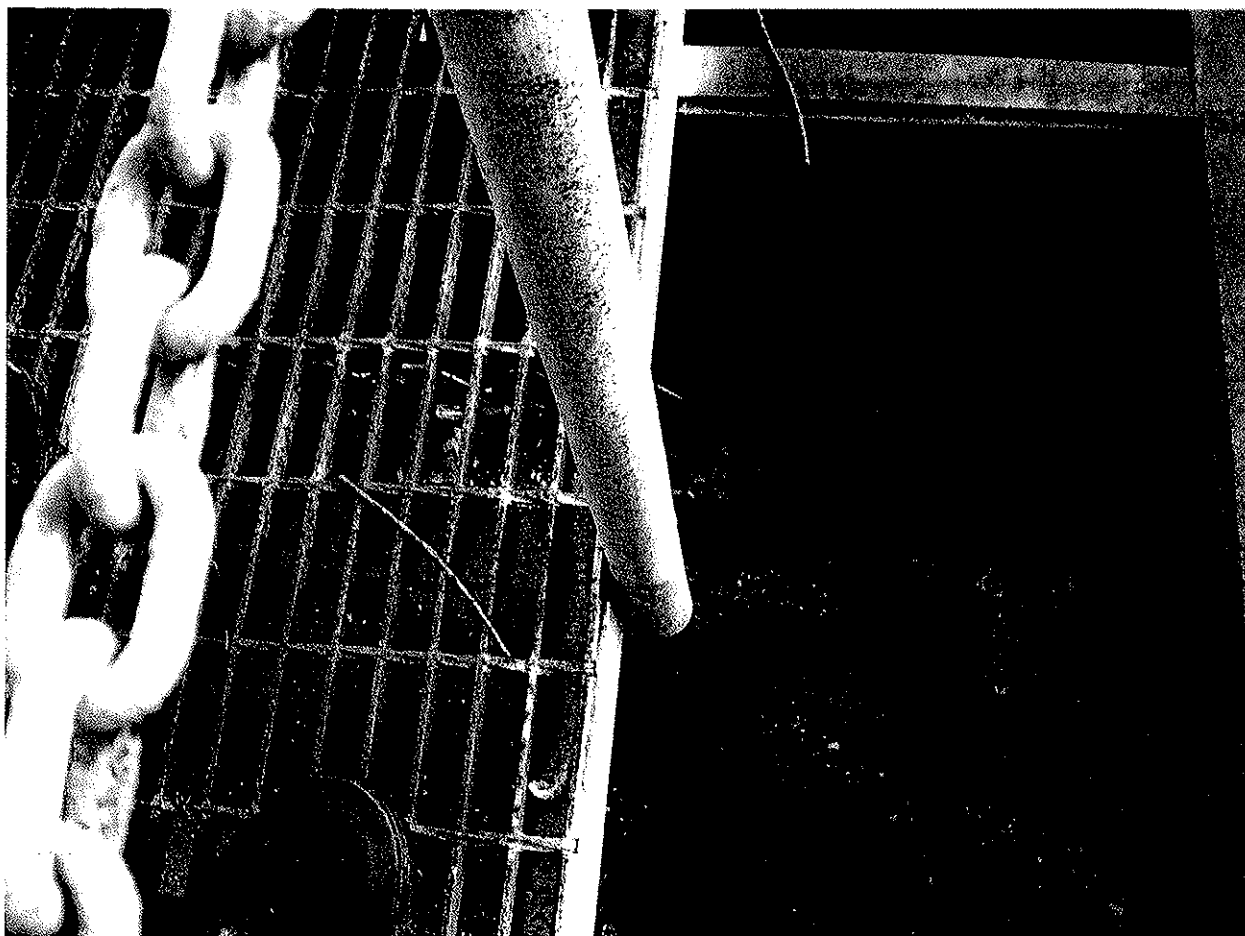
**Subject:** Solids and debris located in the sewage treatment plant

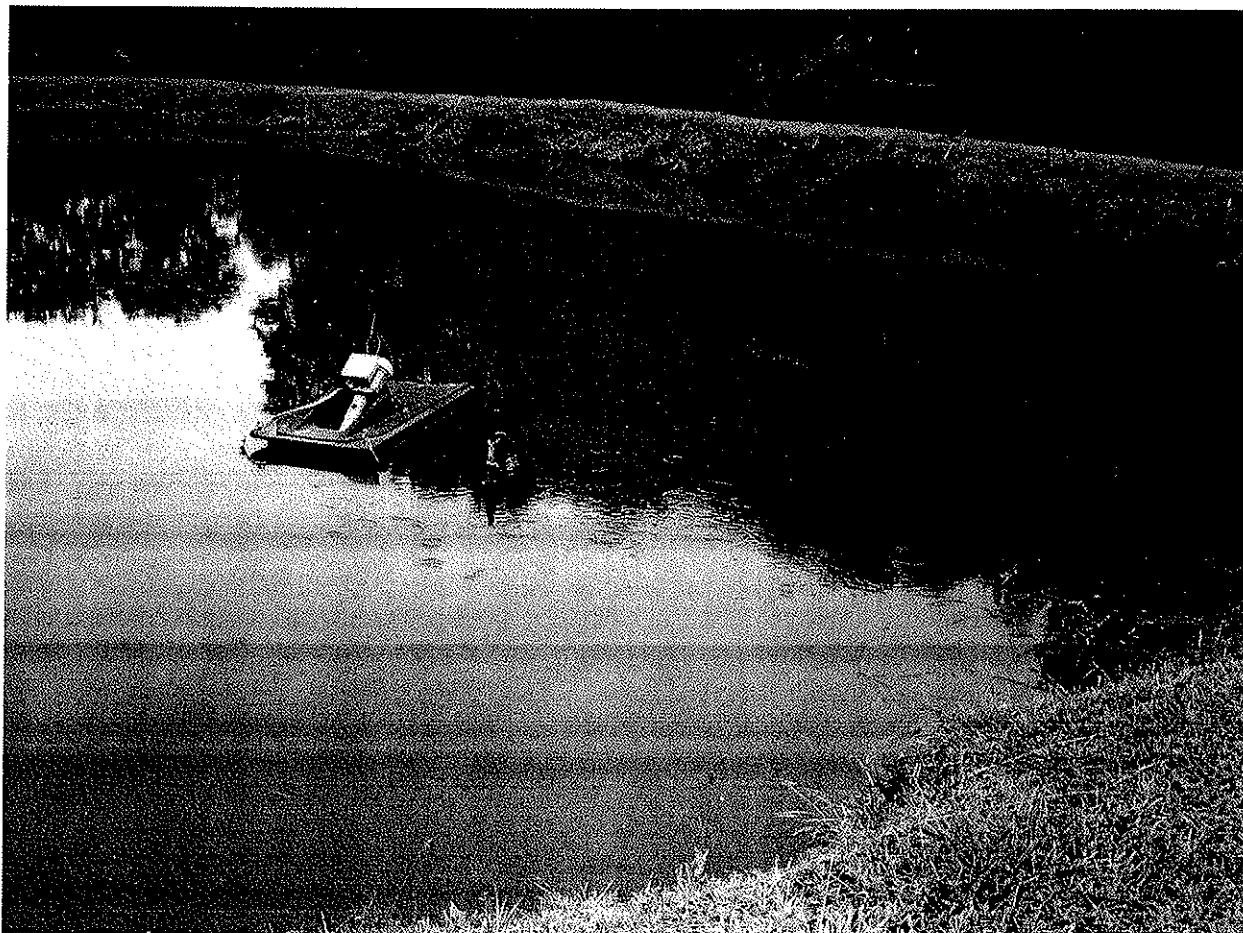
**Subject:** Failed aerator

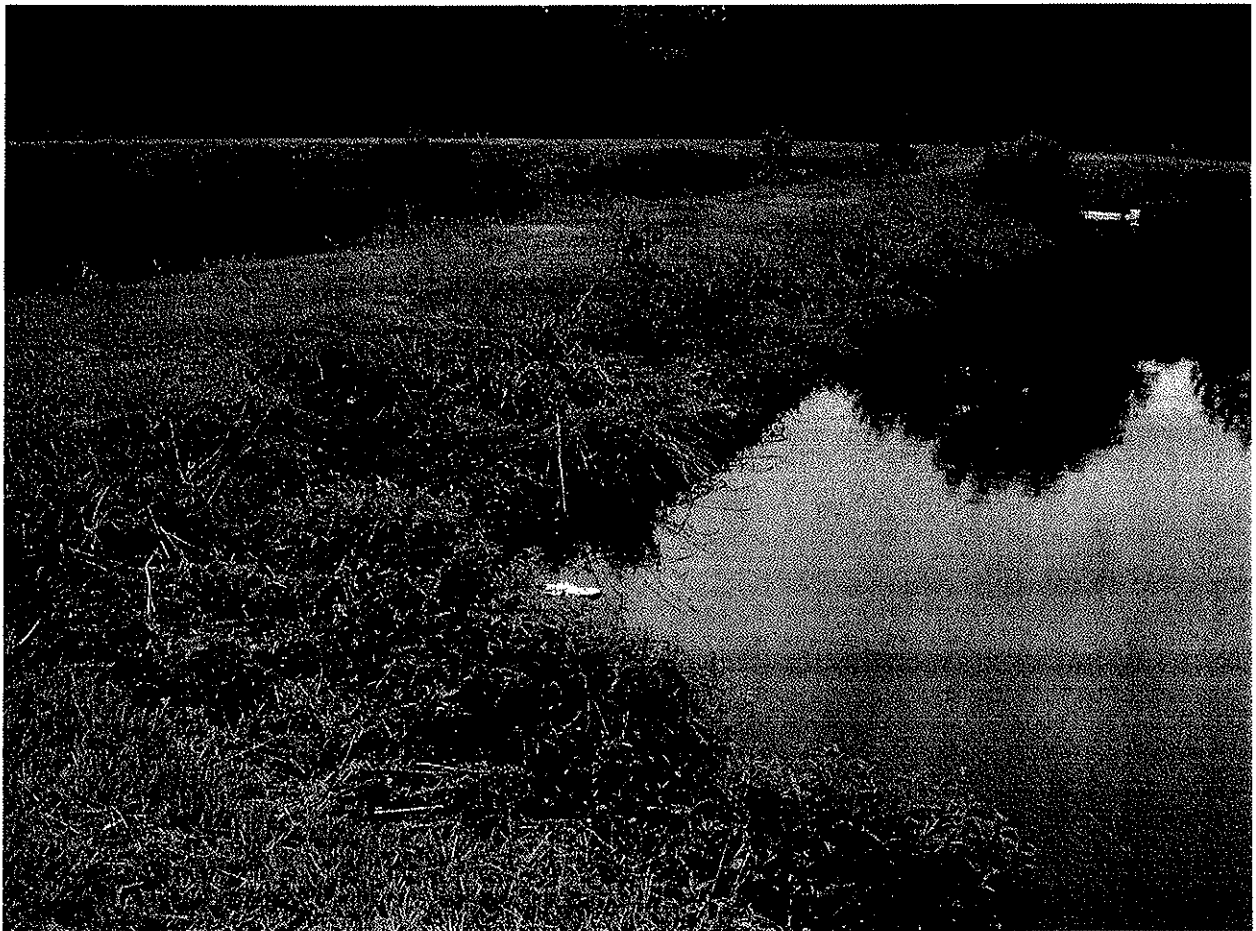
**Subject:** Failed to remove overgrown vegetation from the pond banks

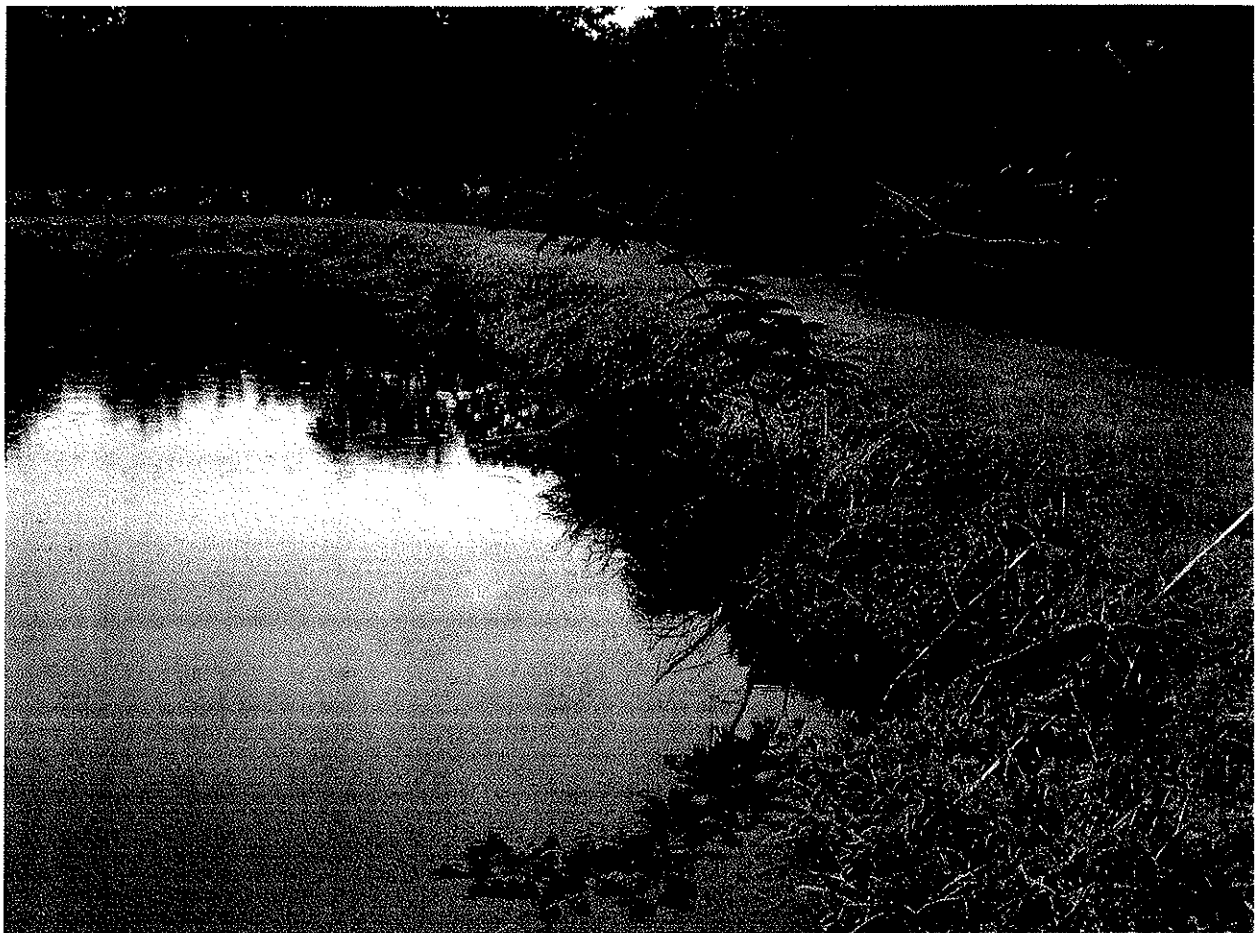
**Subject:** Failed to remove overgrown vegetation from the pond banks

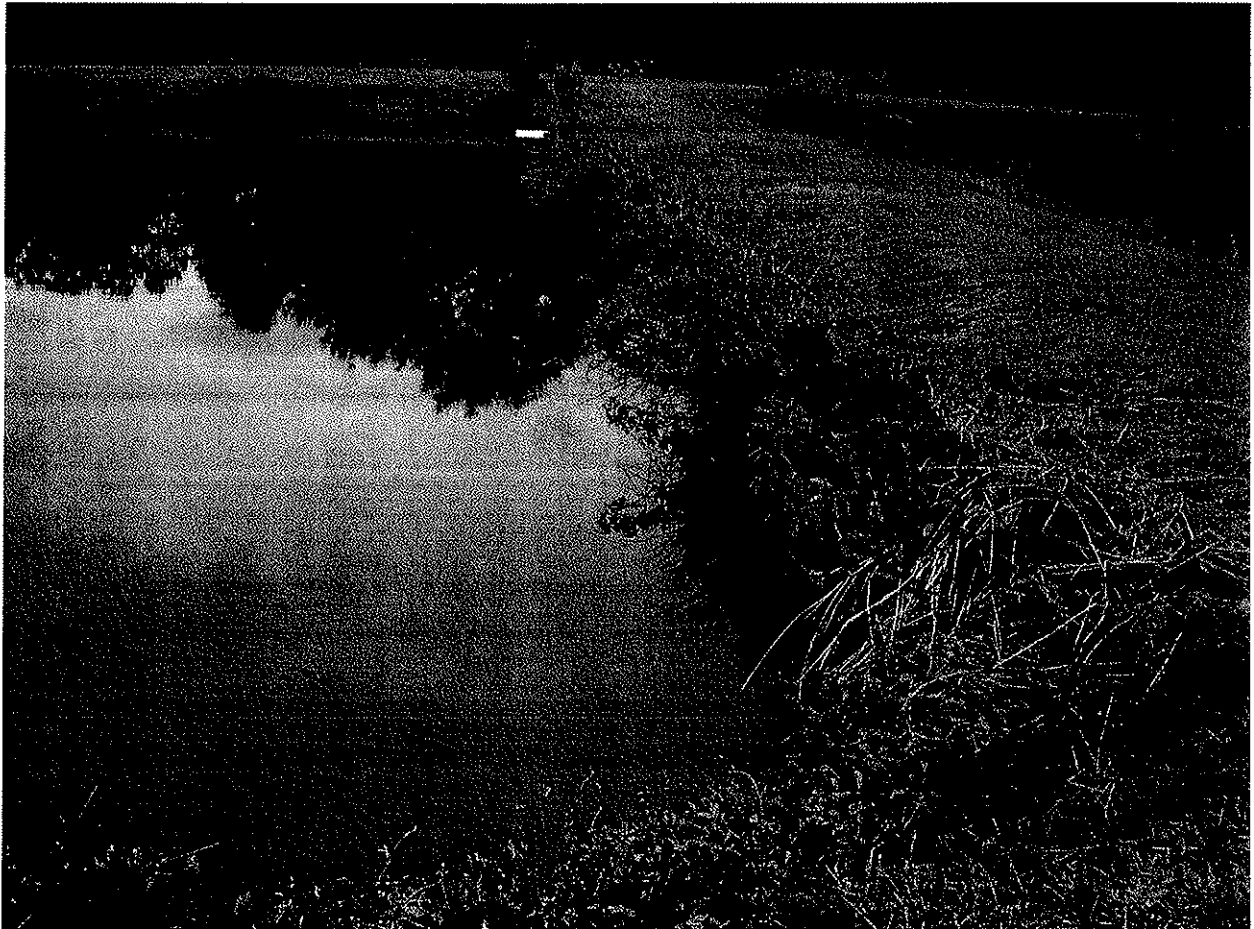
**Subject:** Failed to remove overgrown vegetation from the pond banks

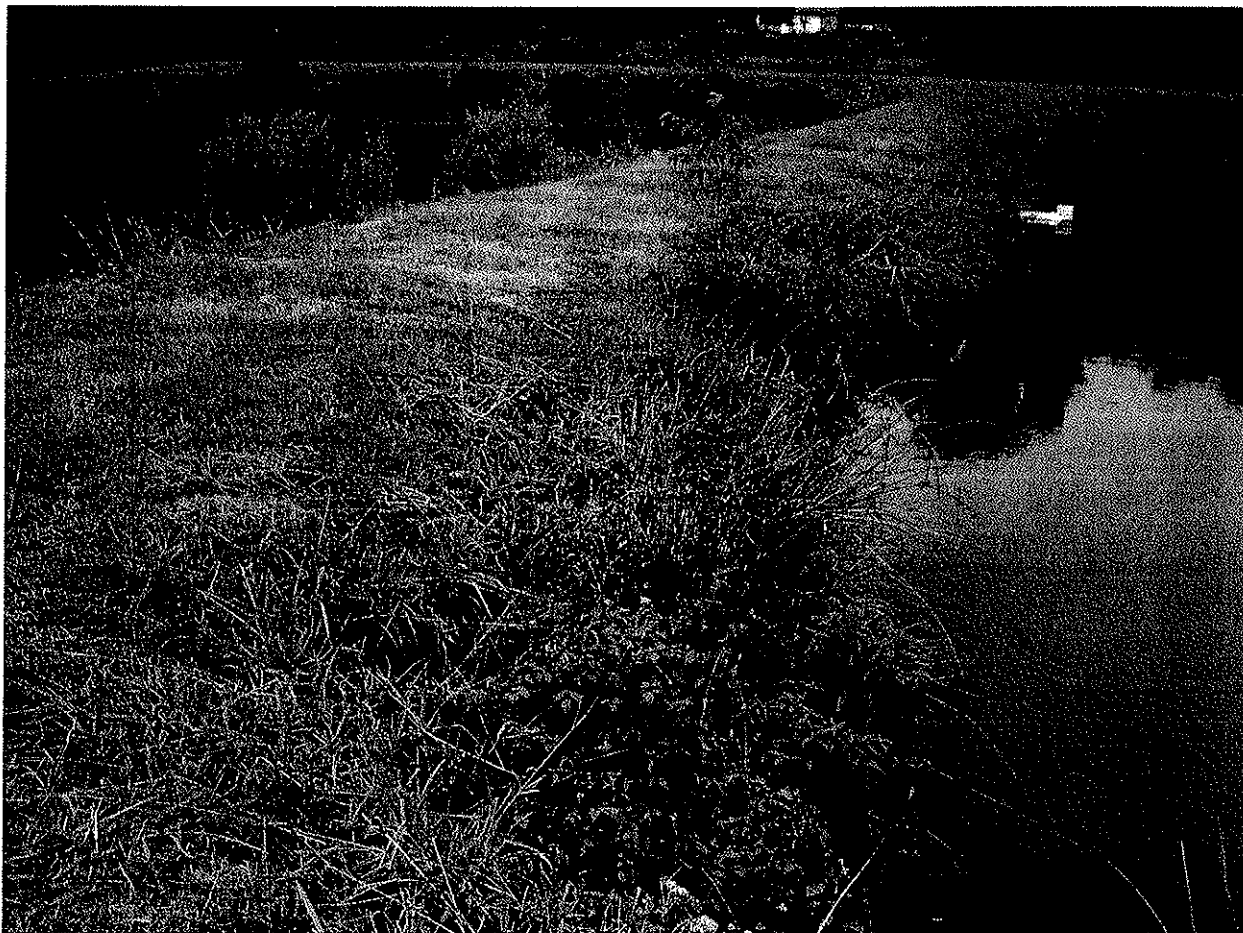
**Subject:** Failed to remove overgrown vegetation from the pond banks
